Construction Fall From Height Accident Reconstruction and Safety Analysis

Erick H. Knox, Steven J. Smith, and Joseph T. Eganhouse

Engineering Systems Inc., 4215 Campus Drive, Aurora, Illinois 60504

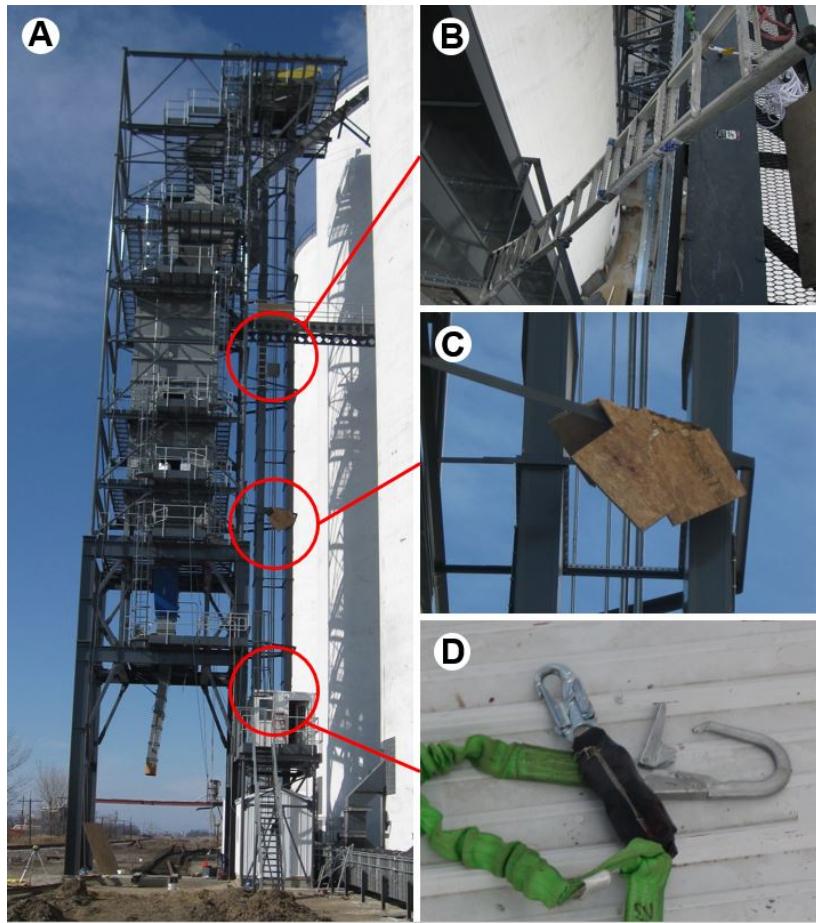
In October, 2012 a 130 foot tall grain elevator system was being constructed to facilitate loading grain into railcars from the adjacent silos. On the day of the accident, an electrical contractor had a 4 man crew working to pull wiring to the top of the structure, and a junction box located between the elevator legs at a height of approximately 75 feet served as the work location (Figure 1A). This particular work location was inaccessible with a boom lift and required the use of personal fall protection equipment outside the guardrails of the structure. The workers placed a makeshift platform on top of adjacent structural steel and accessed this location by climbing down a portable ladder from the adjacent catwalk, which was approximately 10 feet above the platform (Figure 1B). The platform was made out of two sections of OSB panel that had been present at the site and weathered. One of the workers descended the ladder and had tied off his fall protection lanyard to nearby structural steel. Shortly thereafter, the temporary platform failed or became dislodged (Figure 1C) and the worker was seen suspended briefly from his personal fall protection equipment before this disconnected and he fell approximately 50 feet to a structure below (Figure 1D). The worker sustained fatal injuries. Investigators found that the gate of one of the snap hooks on the worker's double leg lanyard was outside of the nose/tip, and that the shock-absorbing component was not deployed or

Figure 1. Accident site.

stretched (Figure 1D). Eyewitness accounts of the accident were incomplete and inconsistent as to where and how the worker secured his fall protection, and the specific sequence of events.

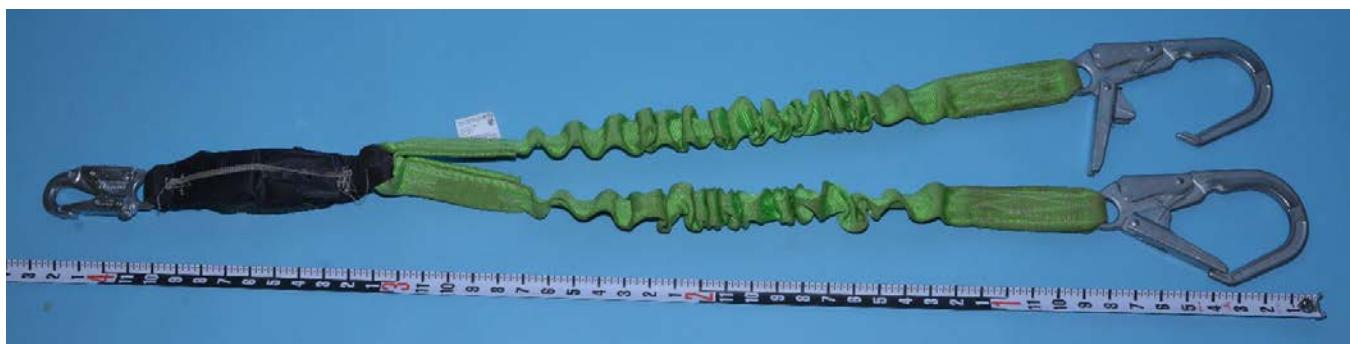
The personal fall protection system utilized by the worker was inspected (Figure 2). The lanyard was an elastic dual leg lanyard with form snap hooks and a shock absorber manufactured in May of 2012. The shock absorber was not deployed or stretched as a result of the fall, possibly indicating a reduced dynamic component to the fall. The snap hooks had locking gates and were manufactured in 2010. One snap hook functioned normally, while the other was damaged: the gate was outside the nose, the left tab of the gate was deformed outward, the left outside corner of the gate was abraded with dark grey transfer, and there were several other witness marks.

Figure 2. Subject lanyard.

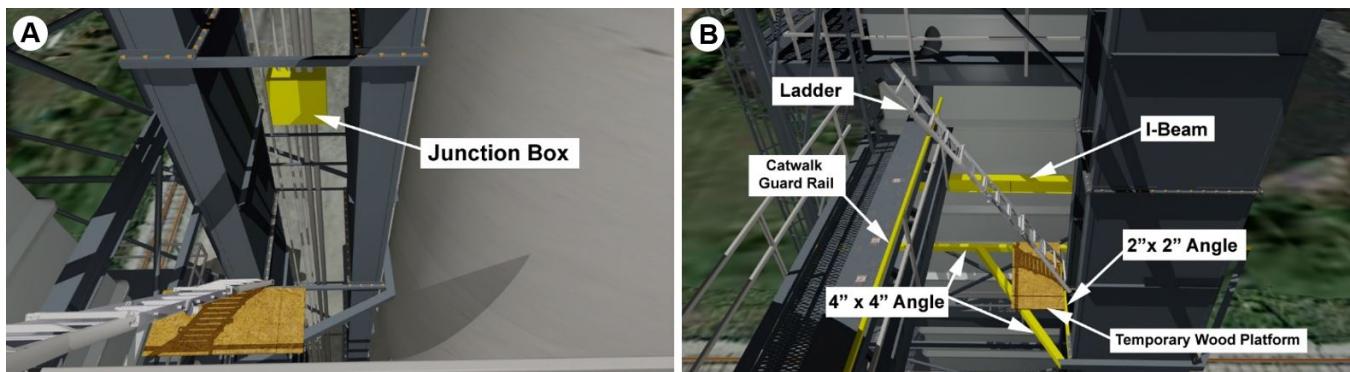
The accident site geometry of the tower structure was documented with a three-dimensional (3D) Faro laser scanner to an accuracy of approximately ± 1 mm at a range of 30 m. This tool provides a 3D point cloud of site geometry and was particularly helpful in documenting inaccessible portions of the structure with line of site laser measurements, and allowed the investigators to measure the site in a safe manner. At the time of the inspection, the accident site had been changed, as post accident remedial measures in the form of a steel platform and guardrails were in place. A 3D computer model of the accident site was generated using the Faro point cloud data to reconstruct and visualize the accident site as it existed on the day of the accident and identify the possible fall protection anchor locations. Figure 3A shows the location of the work site and the

electrical junction box between the grain elevator legs that the workers were going to access as viewed from the catwalk. Figure 3B is a view from above and to the side of the work site that highlights the possible locations identified by witnesses for attaching the fall protection lanyard. This included angle iron at the level of the workers feet measuring 2 inch by 2 inch and 4 inch by 4 inch, as well as a 12 inch by 6 inch I-beam at approximately shoulder level. Both images show the temporary OSB platform properly scaled (31 inches by 63 inches) and supported in an unsecured fashion by the angle iron, as it was at the time of the accident. Note also that the ladder is not supported by the feet on the OSB platform, but is wedged with a rail on either side of an elevator leg.

Figure 3. Three dimensional computer model of the accident site.

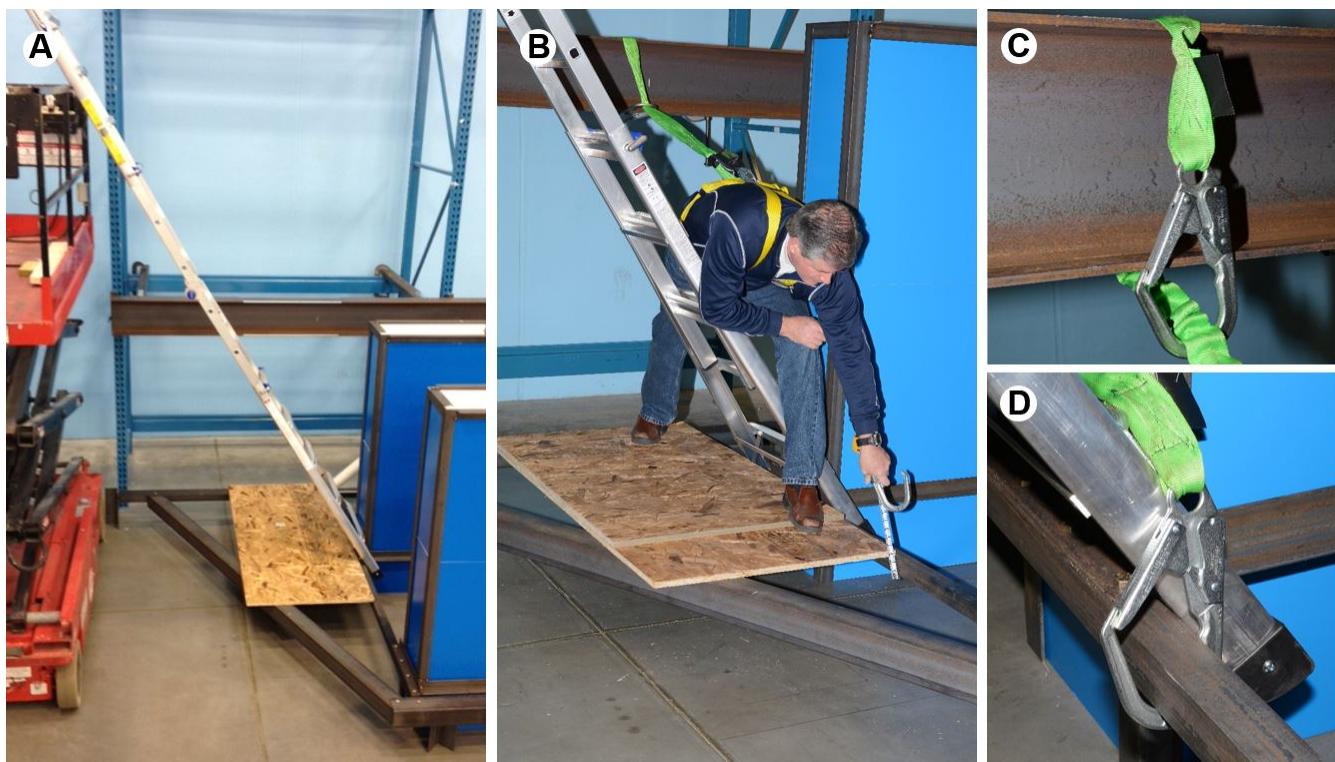
Physical accident reconstruction analysis could not be conducted at the accident site due to safety concerns and the post accident remedial measures. Therefore, the Faro laser scan data was also used to create a dimensionally accurate full scale mockup of the relevant geometry of the accident site at ground level (Figure 4A). In this manner, accident reconstruction hypotheses could be tested safely at ground level using established scientific methods (Knox, 2015). The available data concerning the accident, including the site geometry, physical evidence of the fall protection system, and the witness statements were analyzed to determine the most likely accident sequence. One primary issue concerned resolving the differing witness statements as to where and how the worker secured their fall protection, and whether both legs of the dual leg lanyard were secured. One of the investigators donned an exemplar harness and lanyard and examined the various body positions and lanyard securing options presented at that work location (Figure 4B). It was determined that the worker secured his lanyard back onto itself after wrapping it around the 12 inch tall I beam in a tie-back fashion. Although there are lanyards designed for this method of anchoring, this particular lanyard was not so designed. Witness statements that the worker tied the second leg of the lanyard to the 2 inch by 2 inch angle iron at the opposite edge of the work platform were found to be inconsistent with the reach of the lanyard. Various orientations of tieback and positions of the snap hook over angle iron were examined for their potential to create loading of the gate that would account for the subject snap hook damage (Figure 4C and 4D). It was determined that an external force directed to push the gate inward and to the side was most consistent with the physical evidence. In the final analysis, it was determined that the unsecured temporary work platform broke or dislodged causing the worker to fall suspended on the fall protection lanyard that was incorrectly tied back onto itself. This likely caused the external gate to be forced open and disconnect the lanyard from the structure, although it could not be ruled out that the snap hook was damaged prior to the accident and used with the gate lodged open.

Figure 4. Full scale mock up for accident reconstruction analysis and testing.

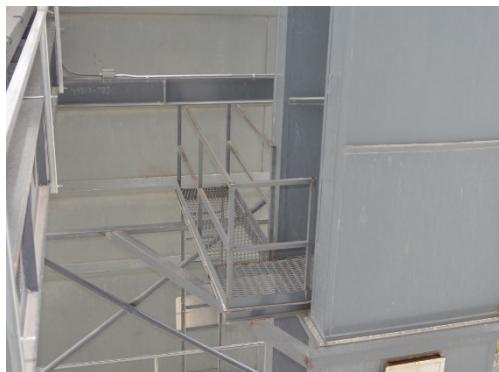
Figure 5. Permanent platform at accident site.

The electrical contractor had identified the need for a work platform in the area of the junction box several weeks prior to the accident. A permanent platform with guardrails was not installed before the accident, in part due to a lack of agreement between the contractors as to who would pay for it. However, a permanent platform was installed after the accident (Figure 5). This system provides a strong stable working surface for safe access to the junction box with no additional need for fall protection. This is the preferred solution over the temporary make-shift OSB platform that failed on the day of the accident. However, at the time of the accident, the electrical crew could also have arranged for a platform suitably designed and rated as a walking/working surface such as scaffold planks with known strengths. Several planks would likely have been necessary because of the space requirements and the fact that more than one individual would be working in the same vicinity. Furthermore, the planks should be secured in place to prevent unexpected movements on a support structure that was not designed for that purpose. If the substandard temporary OSB platform had been replaced by either the now existing fixed steel platform or other suitably strong and secure walking/working surface, the worker's accident would not have occurred. Although there were several misuses of the ladder, this did not likely play any particular role in the accident, but does represent another indication that the work crew did not know and/or follow safe work practices.
