Stump Grinder Accident Reconstruction and Design Testing Methodologies

Dennis B. Brickman¹, Anne C. Mathias¹, and Julius M. Roberts²

¹Engineering Systems Inc., 4215 Campus Drive, Aurora, Illinois 60504

Abstract: This paper presents human factors accident reconstruction analysis and design testing methodologies to address injury modes associated with worker involvement with a tree stump grinder rotating cutter wheel. A broad-based approach was utilized to evaluate present and proposed machine design features, including human factors audible and tactile feedback measurements, in situ cutter wheel control lever testing, real-world cutting testing in non-intended control lever positions, failure mode testing of a proposed safety device, and accident reconstruction methodologies incorporating all these sources of data. Accident statistics analysis indicates that stump grinder rotating cutter wheel contact injuries generally are not prevented by operator presence control designs when two workers are present. Following the operational safety requirements contained in the manufacturer's warnings and instructions, arboricultural safety standards, and the Tree Care Industry Association be

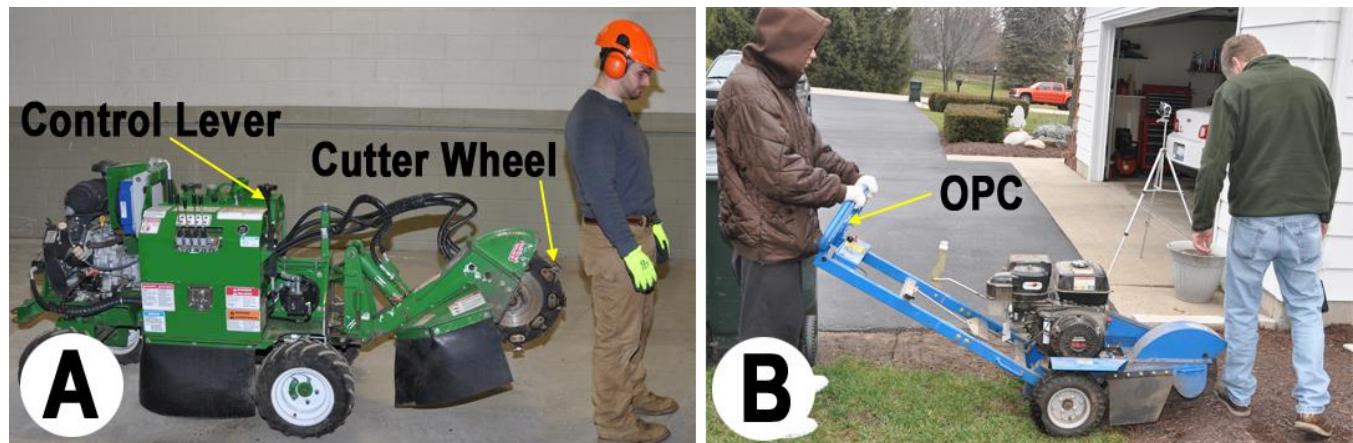
Large stump grinders are heavy-duty cutting machines used in varying outdoor conditions to grind tree stumps and require hydraulic controls for cutter wheel operation. They are utilized by dedicated professionals as well as rented by homeowners for residential use. The Tree Care Industry Association (TCIA) reported a 2014 incident where a Michigan homeowner sustained a leg injury while operating a rented stump grinder at his home (TCIA, 2015). The injured man was working with his neighbor when he walked backwards towards the operating stump grinder; his pants leg then became caught by the powered rotating cutter wheel. Figure 1A shows a reenactment of this Michigan stump grinder accident.

Figure 1. Stump Grinder Accident Reenactments (Large Machine in A and Small Walk-Behind OPC Machine in B)

5. Stump grinder operator struck worker from behind, which pulled decedent into the machine. (NJ)
6. Homeowner injured left leg after contacting cutter wheel of small walk-behind stump grinder (equipped with OPC) operated by landscaper. Accident reenactment is shown in Figure 1B. (2011)

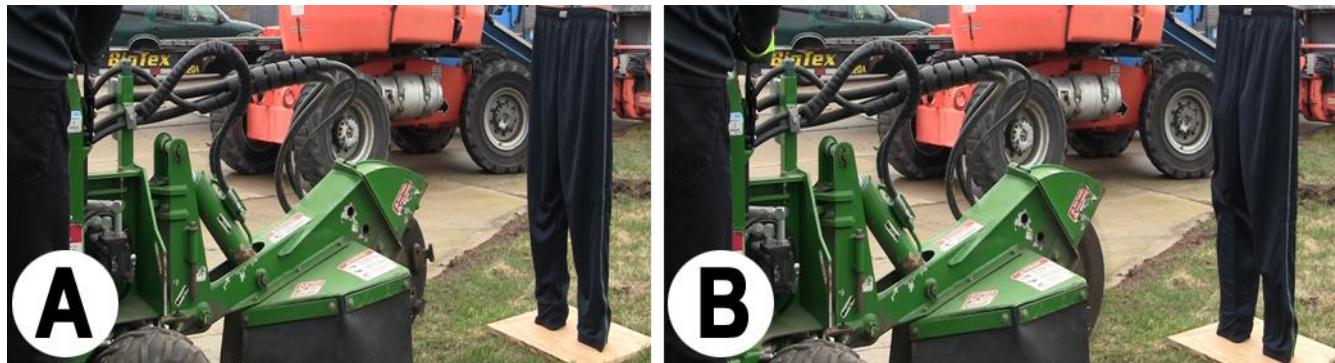
Figure 2. Pants Test Fixture (Cutter Wheel Disengaged in A and Engaged in B)

power, the individual cutting teeth cannot be seen (See Figure 2). This is similar to the behavior of a powered rotating table saw. Additionally, sound level measurements were taken at the operator control position of the stump grinder, and a noted change in pitch during cutter wheel disengagement provided an audible indicator of the change in operating status of the cutter wheel. Air flow testing measured 1,057 feet per minute (cutter wheel engaged) and 0 feet per minute (cutter wheel disengaged) at approximately five feet from the cutter wheel. A test fixture that simulated pants being worn by a surrogate was positioned approximately five feet from the cutter wheel. With the cutter wheel engaged, the air flow caused the loose pants material to flutter (see Figure 2B). Therefore, the injured worker would have had advanced warning that the cutter wheel was engaged through the tactile feedback in his pants even with his back facing the cutter wheel.

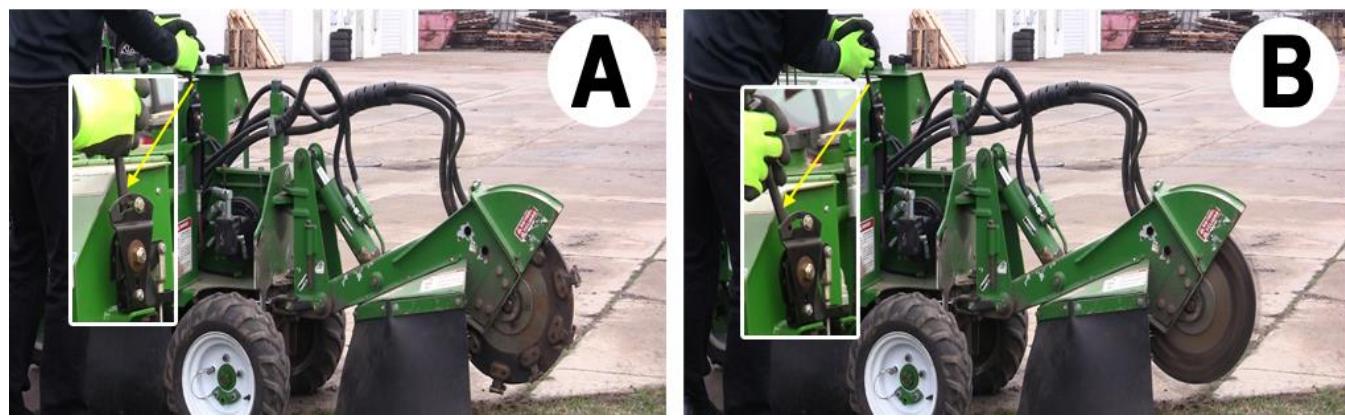
Figure 3. Cutter Wheel Control Lever Testing (Cutter Wheel Disengaged in A and Engaged in B)

Previous studies investigated commercial walk-behind lawn mower control lever failure modes under various conditions (Brickman, 1999). Similarly, cutter wheel control lever testing was performed to analyze the design and operating characteristics of the stump grinder associated with the above 2014 incident. Dozens of cutter wheel control lever tests were performed involving a variety of engine throttle settings by moving the lever from the engaged to the disengaged position. Both lever positions possess a detent which captures the cutter wheel control lever. Changing the cutter wheel engagement condition requires two deliberate control inputs: the top button of the lever must be depressed in order to move the lever out of the cutter wheel engaged and disengaged detent positions. During all test trials, the cutter wheel stopped rotation in a few seconds after the control lever was placed in the disengaged detent position (see Figure 3A). Under all test conditions, the stopped cutter wheel did not reengage spontaneously after the control lever was placed in the detent disengaged position. Even if the control lever was pulled without depressing the top button or even if the button was pressed without pulling the lever, the cutter wheel remained stopped as expected.

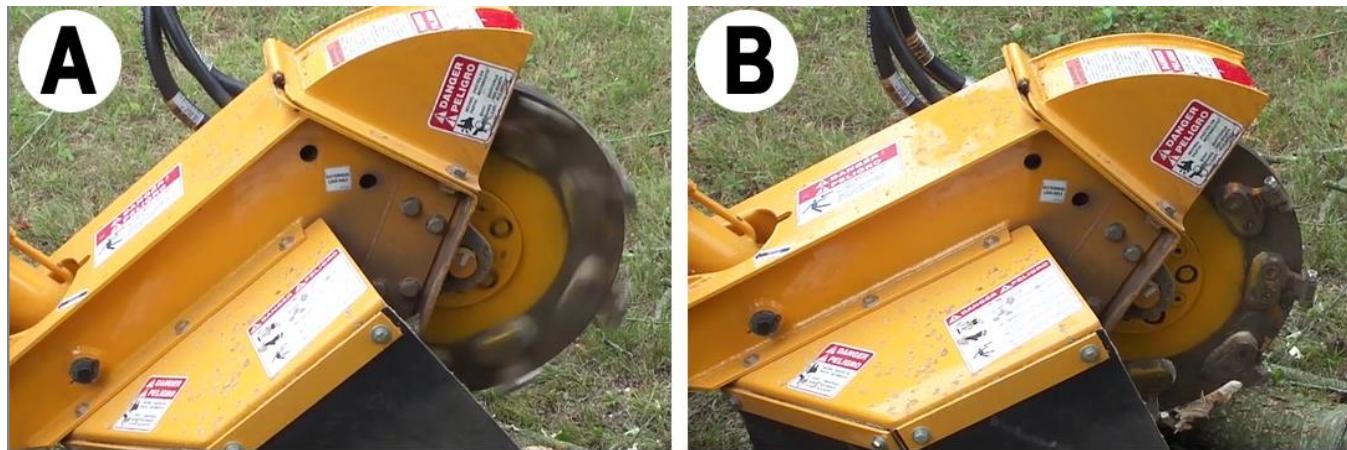
Figure 4. Cutter Wheel Tree Branch Contact Testing (Cutter Wheel Rotating in A and Stopped in B)

The previous testing showed that the cutter wheel stopped rotating only after the control lever was placed in the disengaged detent; it remained rotating while the lever was in between the “engaged” and “disengaged” detents. In order to study the real-world design performance of the stump grinder with the control lever in varying middle positions, various tests were conducted by lowering the rotating cutter wheel onto a six-inch diameter tree branch. A variety of engine speeds and cutter wheel control lever positions were attempted. The cutter wheel control lever was progressively positioned at the $\frac{7}{8}$, $\frac{3}{4}$, $\frac{1}{2}$, and $\frac{1}{4}$ disengagement settings. Under all test conditions, the rotating cutter wheel immediately stopped after making contact with the tree branch (see Figure 4B).

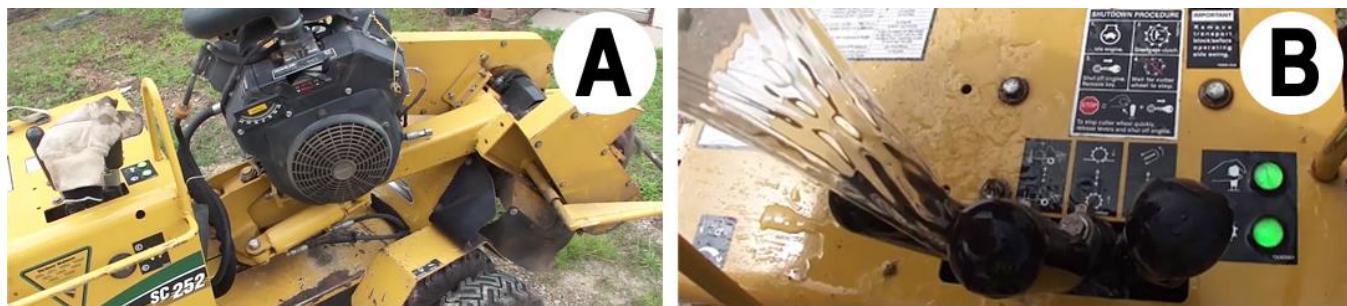
Figure 5. Capacitance-Sensing OPC Testing (Wet Glove Detection Error in A and Water Detection Error in B)

A testing program was performed using a stump grinder equipped with capacitance-sensing OPCs to analyze potential failure modes and effects. Functional problems were experienced during the testing, including the cutter wheel not operating when one of the OPC levers was held with a bare hand and a gloved hand (“false negative”). Also, another OPC lever exhibited intermittent functionality with the OPC lever being less sensitive at the bottom of the lever than the top. Consistent with the Khapochkin 2011 patent, testing of the stump grinder capacitance-sensing OPC indicated that cutter wheel powered operation occurred when the OPC lever was wet even without an operator’s hand contacting the OPC lever as depicted in Figure 5B (“false positive”). In addition, a wet glove placed on the OPC lever without the presence of an operator’s hand enabled the cutter wheel to rotate under power as shown in Figure 5A (“false positive”). Finally, a demonstration was made showing how the OPC lever circuit wiring can be bypassed to allow cutter wheel powered rotation without an operator’s hand contacting the OPC lever as described in the arboriculture online literature.
