# Failure of Fiberglass Ladders Due to Manufacturing Defects

**Abstract:** This paper analyzes the failure of fiberglass ladders due to defects in its rails. These defects were introduced during their manufacturing process in which the fibers are pulled through a resin bath and then through a mold. If the fibers are not fully impregnated with resin and remain dry, a load transfer from resin to fiber cannot take place and hence they cannot support compression loads. As a result, the rail might fail due to high compression stress or due to propagation of a cracks due the voids in the composite matrix.

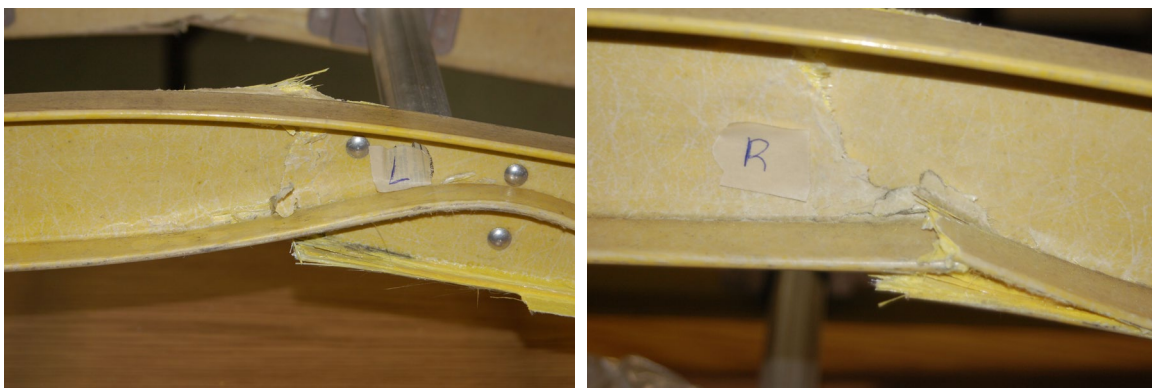
Figure 3. Failure of the extension ladder's rails

**Extension Ladder Failure:** A 24' fiberglass extension ladder type 1AA with load capacity of 350[lb] was used with extended length of 18.6ft. (Out of 21' maximum working length). A 195[lb] male, was performing an ordinary task while standing on the fifth rung from the top. Once he completed his work, he started to step down the ladder and when he stepped on the 6<sup>th</sup> rung from the top, the rails of the extension broke just below the 7<sup>th</sup> rung (Figure 3).

Analysis of both cases resulted in stress levels below the requirement specified in ANSI A14.5-2000 standard. Thus, it was concluded that the failures were due to local irregularities in the GFRP extrusion due to the manufacturing process or damage caused by inappropriate use or during transportation. Close inspection of the rails at the proximity of the failure locations did not reveal any external damage.

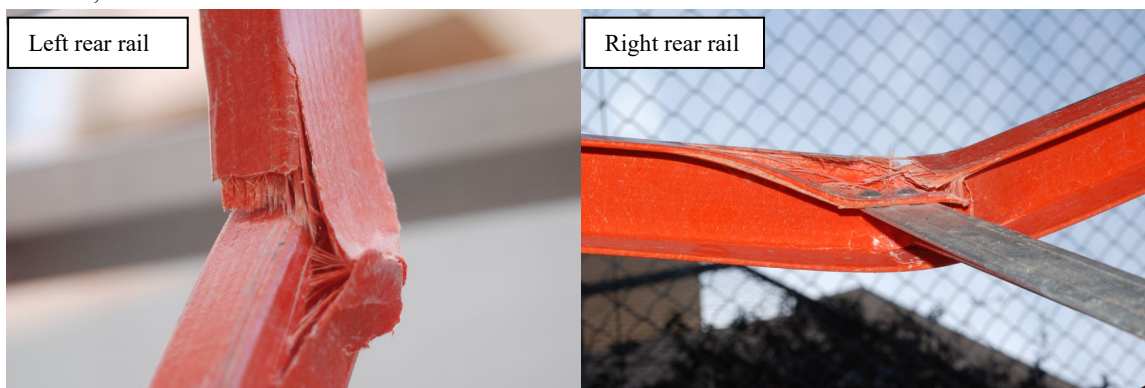
Figure 4. Failure of step ladder's rails

**Step Ladder Failure:** A 150[lb] worker was climbing a new 300[lb] capacity 12[ft] fiberglass step ladder. While standing on the 10<sup>th</sup> rung, the rear right rail of the ladder broke (buckled, failed). (Figure 4).

There are manufacturing defects like: cracks due to machining (e.g. drilling holes for rivets, see Figure 4); broken fibers; fiber waviness; stress concentration due to holes (Abdalla et. al. (2014)). These will be discussed here since they are difficult to detect after the failure.

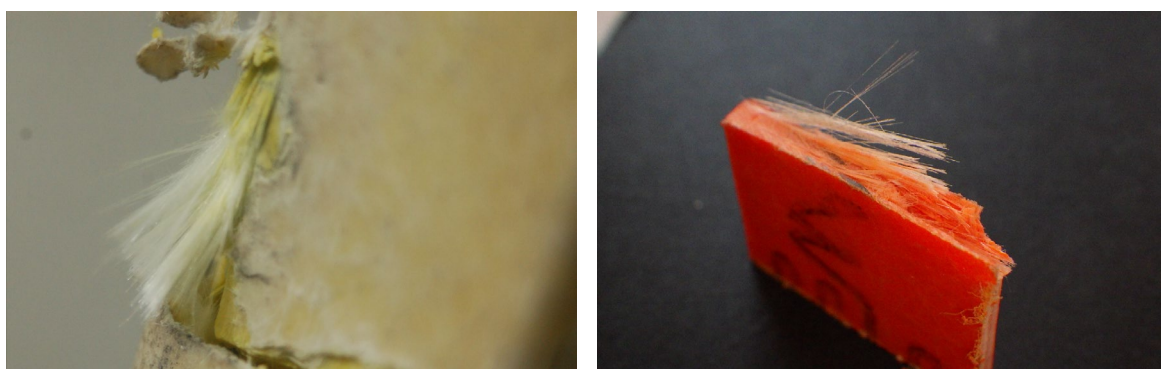
Figure 5. Dry glass fibers

Further inspection of the fracture site revealed strands of "dry" fibers at the failed cross-section (Figure 5). These dry fibers can be identified by their white color since they were not wetted by the colored resin. This defect is caused by high fiber fraction (Shakaya et. al. (2016); Binshan et. al. (1995); Abdalla et. al. (2008)) which is the ratio of the fibers' volume to the total volume of the composite. High fiber volume ratio means that the fibers are so close to each other that the resin cannot penetrate and wet all of them. Accepted values for fiber volume fraction range from 50%-60%. For verification, samples were cut from web and the flange of rails in proximity to the failure and were tested according to ASTM D2584-2011. The results, shown in Table 1, indicate the fiber volume ratio in both cases was high, causing the failure.

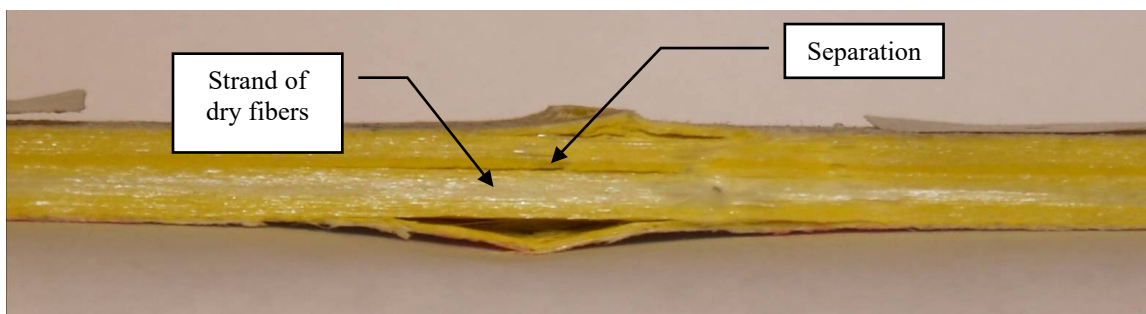
Figure 6. Separation due to dry fibers

In addition, a strand of dry fibers can cause a separation between the flange and the web (Figure 6), reducing the area moment of inertia of the cross cross-section by almost half. This causes an increase of bending stress by a factor of two and reduces the critical buckling force the same. Also, it can propagate as a crack along the rail with this effect.

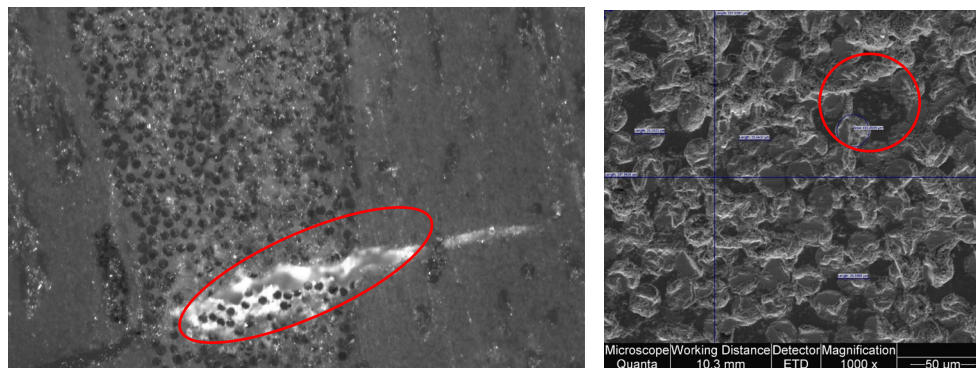
Figure 7. Voids

“In Liquid Composite Molding processes (including pultrusion), there are several causes for void formation such as mechanical air entrapment during resin flow (main cause), gas created due to chemical reactions during cure, and nucleation of dissolved gases in the resin. The air entrapment is mainly due to the inhomogeneous fiber architecture, resulting in non-uniform permeability of the fiber preform, which causes local variation in resin velocity. This local velocity variation is exacerbated by the capillary effect, prevailing at the micro-scale” (Manhoor et. al, (1991); Weiguo et. al, (2012); Little et. al. (2012); Saenz – Castillo (2019)). The effect of the voids is a local stress concentration and crack formation/separation that might lead to a failure (see Figure 7).
