Classification of Wood Chipper Accident Types: Influence of Bottom Bump Bar

Dennis B. Brickman¹, Erick H. Knox¹, Anne C. Mathias¹, Christopher P. Eckersley²
and Lance E. Rewerts³

Keywords: Wood Chipper, Accident Types, Bottom Bump Bar

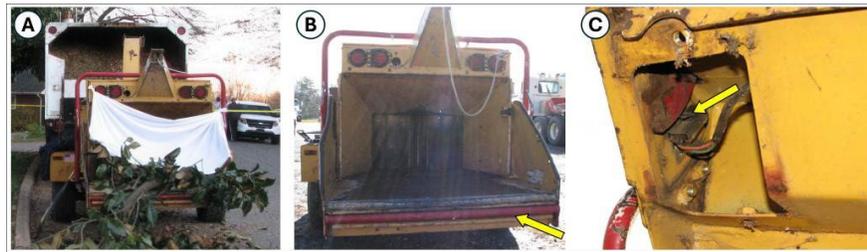
Figure 1. Commercial Wood Chipper Equipped with Bypassed Electronic Bottom Bump Bar Involved in Fatality

The chipper was equipped with an electronic bottom bump bar, which was found pushed in and stuck in the locked off position, as shown in Figure 1B. A pry bar had to be used to get the bottom bump bar back into the on position after the accident. If the bottom bump bar was functioning properly, the feed system cannot be restarted without operator pressing the reset button. The spring that pushes the bottom bump bar back into the operating mode was missing. The two electronic switches on each side of the bottom bump bar were not operating, which prevented the signal from being sent to stop the chipper feed rollers, as displayed in Figure 1C. The employer knew the bottom bump bar was not functioning and knew the operator's manual instructed the chipper not to be operated if the bottom bump bar was not functional. The employer stated that the chipper feed rollers would constantly stop if the bottom bump bar was operational, preventing work from getting done.

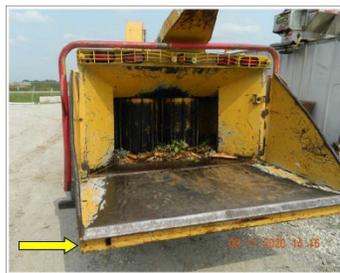
Figure 2. Wood Chipper with Removed Electronic Bottom Bump Bar Involved in Climbing Rope Fatality

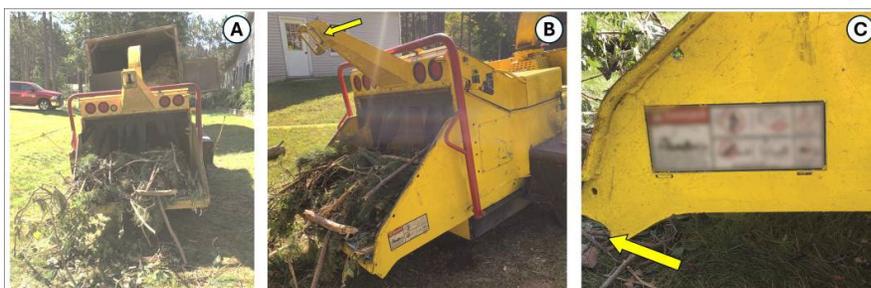
Figure 3. Wood Chipper with Removed Electronic Bottom Bump Bar Involved in Winch Line Rope Fatality

On September 1, 2021, an employee was fatally injured when he experienced blunt force trauma to his head and face while winching tree debris with a commercial wood chipper winch line rope in Michigan (OSHA, 2021). The accident site was in a subdivision with houses on both sides of the site, as exhibited in Figure 3A. The tree crew had cut down approximately eight large red pine trees approximately seven to eight inches in diameter and 30 feet tall and were working on the last tree when the unwitnessed incident occurred. The employee had brush and tree limbs attached to the winch line rope and was near the wood chipper controls. After the incident, there was very little rope still attached to the winch, because the vast majority of the rope had gone through the chipper, as depicted in Figure 3B. The rope had been shredded and the bulk of it had been thrown into the box truck via the discharge from the chipper. The MIOSHA investigation and photographs taken at the incident site determined that the electronic bottom bump bar had been removed from the chipper at the time of the incident, as indicated by the arrow in Figure 3C.

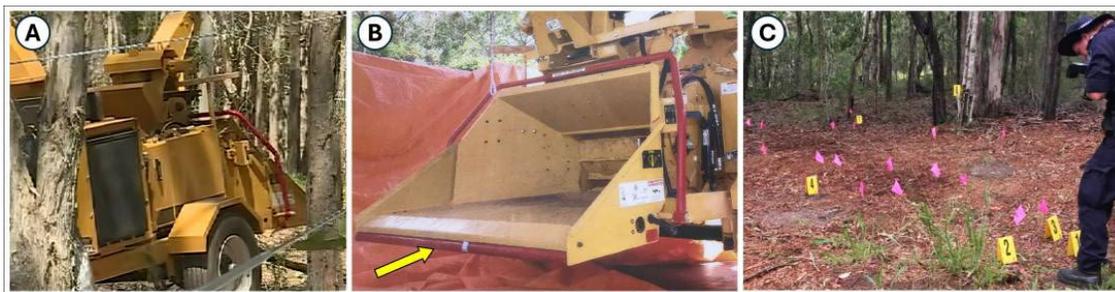
On November 12, 2017, a 54-year-old man reportedly was killed in an industrial-grade wood chipper exhibited in Figure 4A near Gympie, Australia when he was working with two men on the property (The Courier Mail, 2018). The wood chipper was equipped with a bottom bump bar, as depicted in Figure 4B. The coworkers told the owner of the property where the victim died, shown in Figure 4C, that he had been leaning back into the chipper as well as standing on top of it. The two coworkers originally told investigators that they did not see the victim enter the wood chipper, but they did find him inside the chipper and tried to pull him out. The death was initially deemed an industrial accident. The accidental death was upscaled to a murder investigation. An investigator made a technical assessment of the 15-inch wood chipper blade that was ruled out as a cause of the victim's death. An investigator stated that the chipper was set up in a way that if a user fell, they would not be pulled straight into the chipper. The coworker, who was clearing trees with the victim, was accused of killing the victim (ABC, 2022). During the murder trial, the court was told that the chipper was used to make the victim's death look like an accident. Police footage showed the victim's legs protruding from the wood chipper. The accused man later admitted to disposing of the victim's body at the beginning of his trial. The accused man was sentenced to life in prison after being found guilty of murder.

Figure 4. Commercial Wood Chipper Equipped with Bottom Bump Bar Involved in Homicide

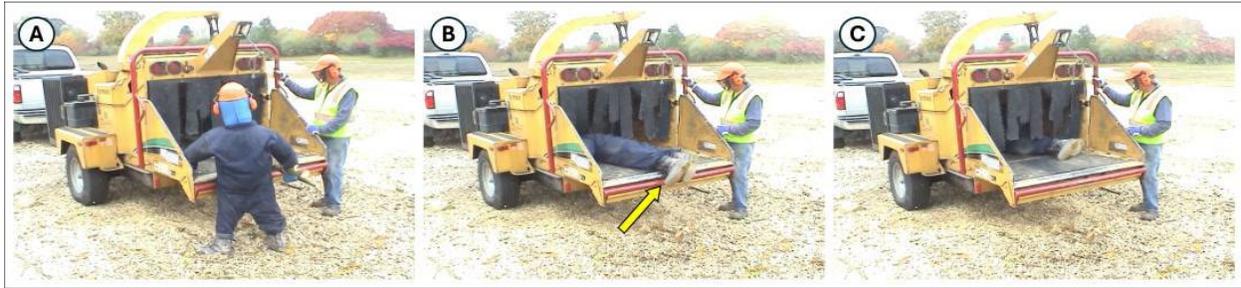
Figure 5 demonstrates Big Blue dummy testing associated with a commercial chipper electronic bottom bump bar similar to that shown in Figure 1. In Figure 5A, the standing dummy's right hand is tied to a branch being fed into the chipper

Figure 5. Big Blue Dummy Does Not Activate Electronic Bottom Bump Bar During Branch Pull-In Test

feed rollers. In Figure 5B, the branch passes through the feed rollers, and the dummy's feet get pulled off the ground and contact the bottom bump bar. In Figure 5C, as the dummy's head and torso enter the rotating feed rollers, the dummy's feet are dragged against and over the bottom bump bar without activating it, and the feed rollers are not stopped. This testing result is consistent with real-world commercial chipper incidents as presented in the accident type literature review.

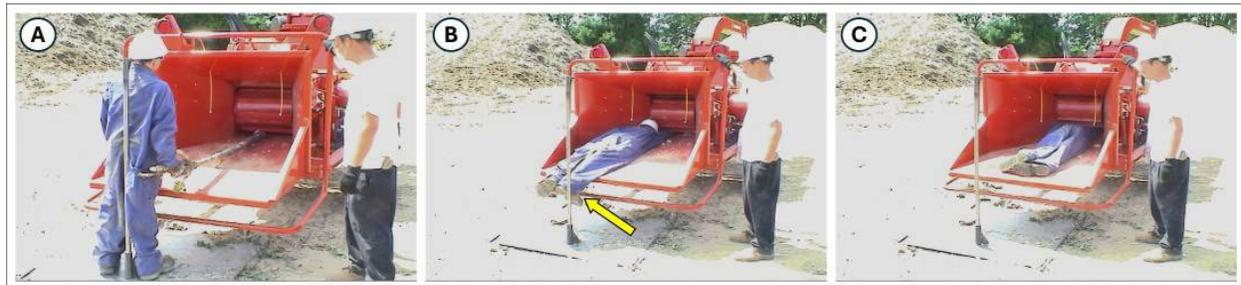
Figure 6. Rescue Randy Dummy Does Not Activate Hydraulic Bottom Bump Bar During Branch Pull-In Test

Figure 6 demonstrates Rescue Randy dummy testing associated with a commercial chipper bottom bump bar typically used in Europe. The mechanical bottom bump bar is connected to the safety control bar and controls the hydraulic feed rollers. In Figure 6A, the standing dummy's right hand is tied to a branch being fed into the chipper feed rollers. In Figure 6B, the branch passes through the feed rollers, and the dummy's feet get pulled off the ground and contact the bottom bump bar. In Figure 6C, as the dummy's head and torso enter the rotating feed rollers, the feed rollers did not stop when the dummy's feet are dragged against and over the bottom bump bar. This testing result is consistent with real-world commercial chipper incidents described in the accident type literature review.

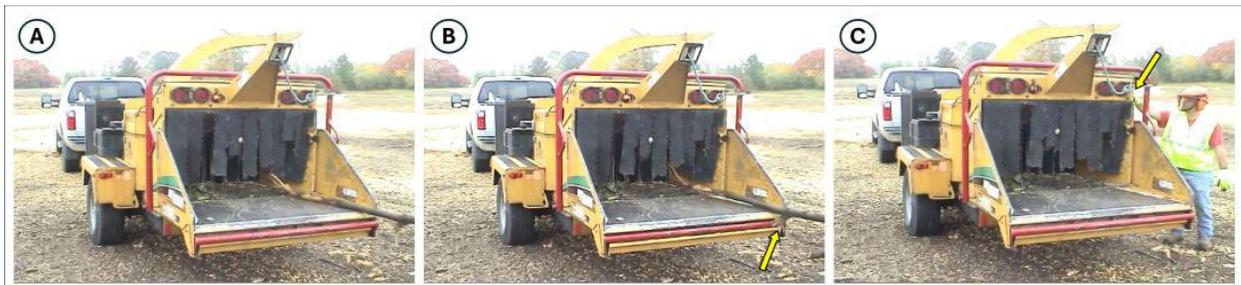
Figure 7. Branch Contacts Electronic Bottom Bump Bar Causing Nuisance Shut Down (B) & Control Reset (C)

Figure 7 displays video still frames showing the nuisance shut down of the commercial chipper feed rollers when a branch contacts and activates the electronic bottom bump bar. In Figure 7A, the branch is being fed into the infeed chute. In Figure 7B, the branch contacts and activates the bottom bump bar, which stops the feeding operation. In Figure 7C, the operator has to reset the chipper controls after the electronic bottom bump bar activation to continue feeding brush into the chipper. This testing result is consistent with the accident type literature review where an employer stated that the wood chipper feed rollers would constantly stop if the bottom bump bar was operational preventing work from getting done (OSHA, 2016).
