Accident Reconstruction of a Ladder Slide-Out: Integrating Human Factors, Design, and Safety

2. Subject Incident Description

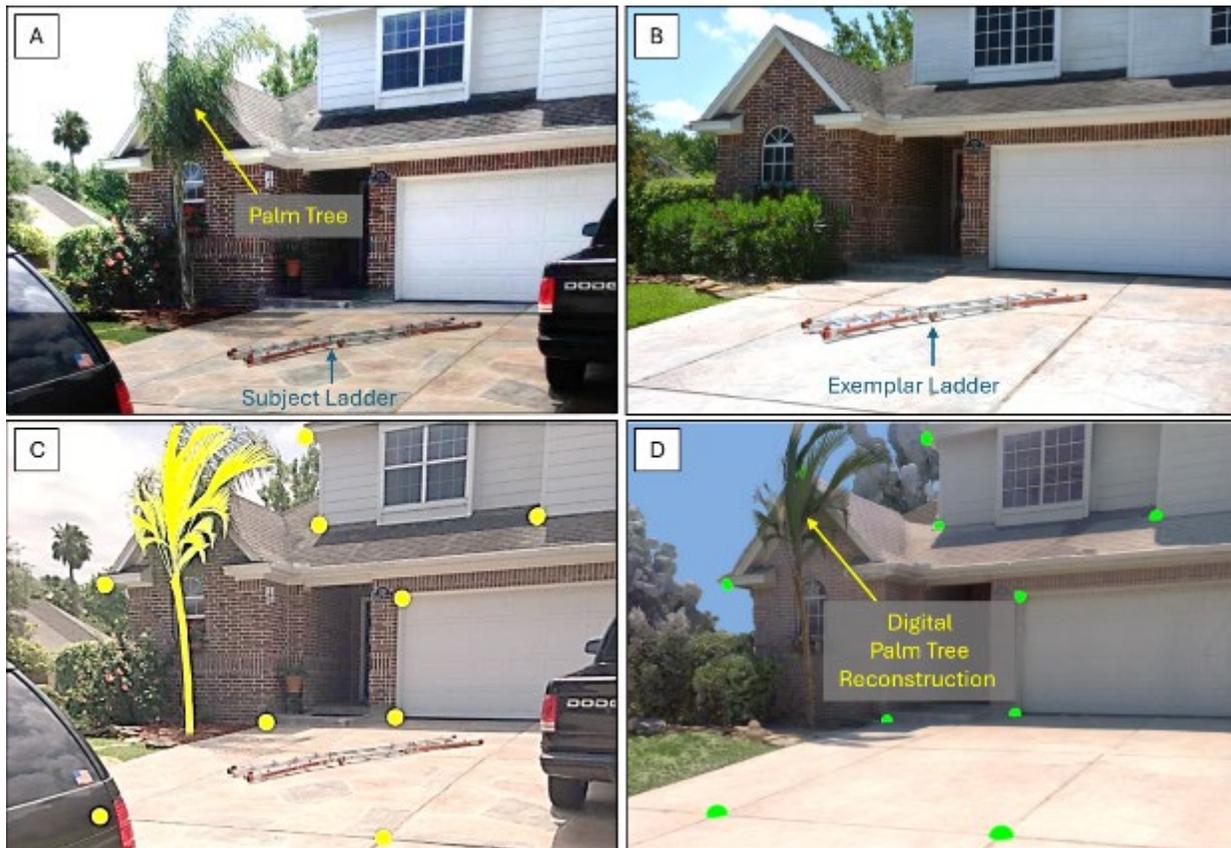
Accident reconstruction methods utilized the scientific method as the framework for determining the most likely sequence of events and included consideration of human factors, ladder design, and safe work practices (Knox et al., 2015). The worker's visibility from the witnesses' perspectives was central to the analysis, with their testimony providing critical guidance for the investigation. Figure 1A shows a photograph of the subject incident site with the subject ladder laying on the driveway shortly after the injured worker was removed from the scene by EMS. Figure 1B shows an image of the incident scene at the time of site inspection. An exemplar ladder was used to reconstruct the position of the subject ladder. Note that the palm tree that was present in the garden area at the front of the house at the time of the incident was removed prior to the site inspection. The incident site was documented with FARO laser scanning, and a three-dimensional (3D) digital model of the site was created. The size and location of the palm tree were an important consideration in what the witnesses were able to see, so advanced 3D digital analysis methods were used to virtually reconstruct a palm tree and place it into the 3D virtual site model using a camera matching utility and corresponding points in the photo (Figure 1C) and the digital model (Figure 1D). The digitally reconstructed palm tree is seen in Figure 1D.

Figure 1. Site Geometry with digitally reconstructed palm tree

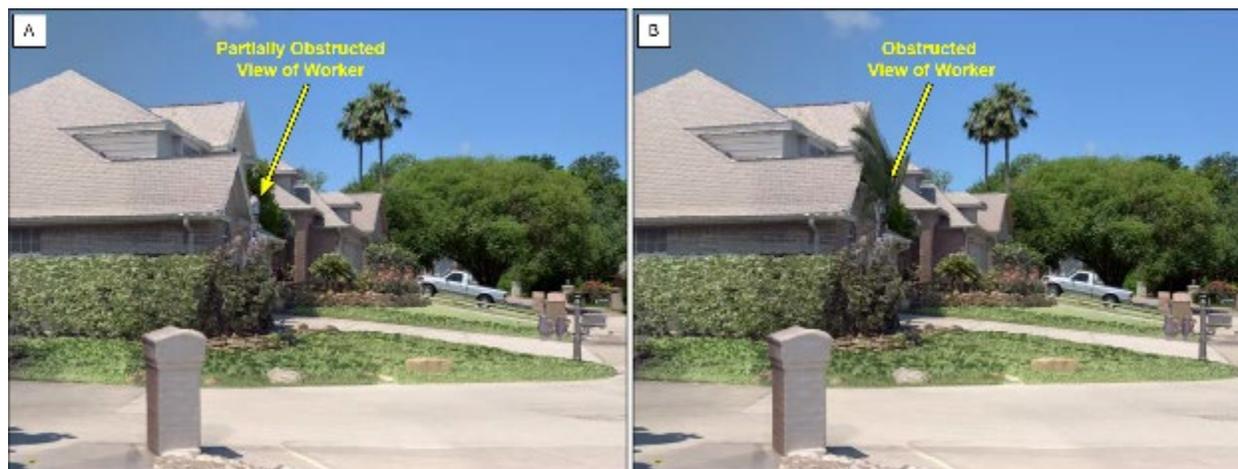
Blood stains on the driveway, as well as knowledge of the ladder geometry and worker anthropometry, were used to determine the final rest position of the worker and the location where the ladder was set against the gutter. Figure 2 models the ladder at this location with the worker on the ladder. This figure also shows the general location of the witnesses residing across the street. It is noted that the palm tree is in these witness' line of sight, obstructing their view of the ladder and worker. Figure 3A shows the 3D virtual site model, with the worker on the ladder but without the palm tree. The geometry of the house and nearby vegetation obscures a large portion of the worker's body and ladder. When the digitally reconstructed palm tree was added to the 3D virtual model, the worker was fully obstructed from view (Figure 3B). Additional analysis showed that only a portion of the worker and the ladder could be viewed during a portion of the fall sequence from the witness' testified location. It was concluded that the worker could not have been seen as described by the witness.

Figure 2. Virtual model with reconstructed view of the worker from the witness' location A) without palm tree, B) with digitally reconstructed palm tree

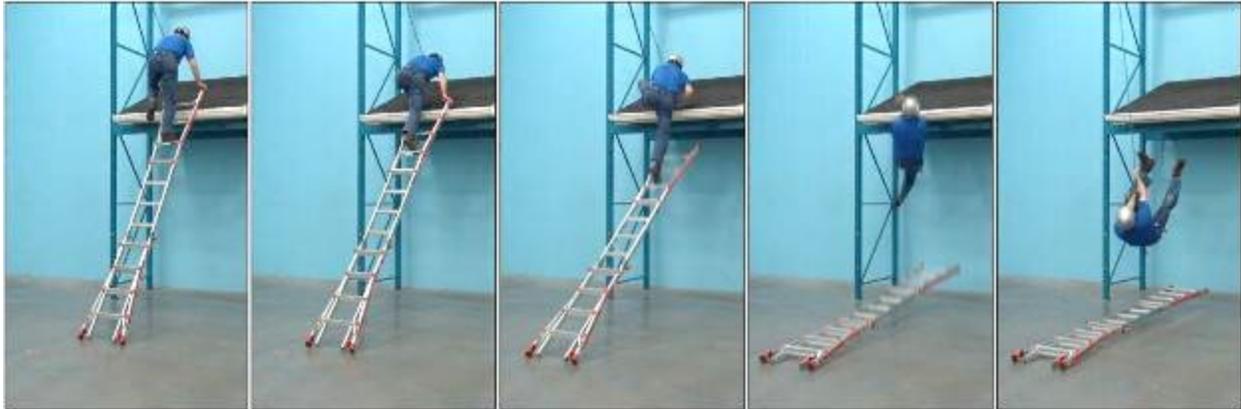
Figure 4. Fall kinematics during slide out while transitioning to a roof

In the subject incident, the worker fell and came to rest with his head further away from the house and his feet closer to the house. Generally, in slide-out incidents in which the user rides down with the ladder without touching or grabbing anything else, their body ends up in the opposite orientation with their head closer to the top support. Laboratory testing was conducted to study and demonstrate the kinematics of a ladder user during a slide-out that begins when the user is transitioning to a roof. A user, who was protected from falling through a climbing harness and belay, ascended an exemplar ladder that was leaned against the gutter of the site mock-up. During the transition to the roof, the ladder began to slide out, and the continued loss of support from the ladder caused a downward falling motion for the user. However, the leg that was on the roof caused the user to rotate backward and off the roof in a generally supine position (Figure 4). Additionally, portions of the user's body were directly above the ladder. The user, in a true fall, would have therefore landed on top of the ladder. It is important to note that the subject ladder exhibited damage consistent with being impacted while flat on the ground. The laboratory findings of the user kinematics and trajectory of the fall were consistent with the evidence provided in the subject incident that the worker was found face up on top of the ladder.

The available evidence indicates that the worker set the ladder on the sloped driveway and against the horizontal first-story gutter of the house. As he was transitioning to the roof, the ladder began to slide out, causing his body to fall down and rotate backward off the edge of the roof. He struck and damaged the ladder below him. He also impacted the concrete driveway with the back of his head, ending up lying partially on the ladder in a face-up orientation.

Less-than-ideal site conditions such as sloping surfaces, can be mitigated by lashing, footing, or otherwise securing the ladder from movement (Hepburn, 1958). Ultimately, ladder users must read and follow on-product warnings and instructions.
