## Beach Rental Elevator Child Entrapment Safety Analysis

**Abstract:** A human factors accident reconstruction was conducted to analyze the circumstances surrounding a beach rental elevator ten-year-old child entrapment accident in South Carolina. The elevator control circuit allowed the elevator car to move with the accordion door open, posing a crushing hazard. This accident would have been prevented had the elevator been equipped with an adequate light curtain safety feature offered by the elevator manufacturer on its other elevator models. Following this accident, a petition for recall to repair/retrofit and rulemaking was submitted to the U.S. Consumer Product Safety Commission (CPSC) to promulgate a mandatory standard for residential elevators and to commence a recall requiring all manufacturers to retrofit existing elevators to prevent children and small adults from becoming entrapped.

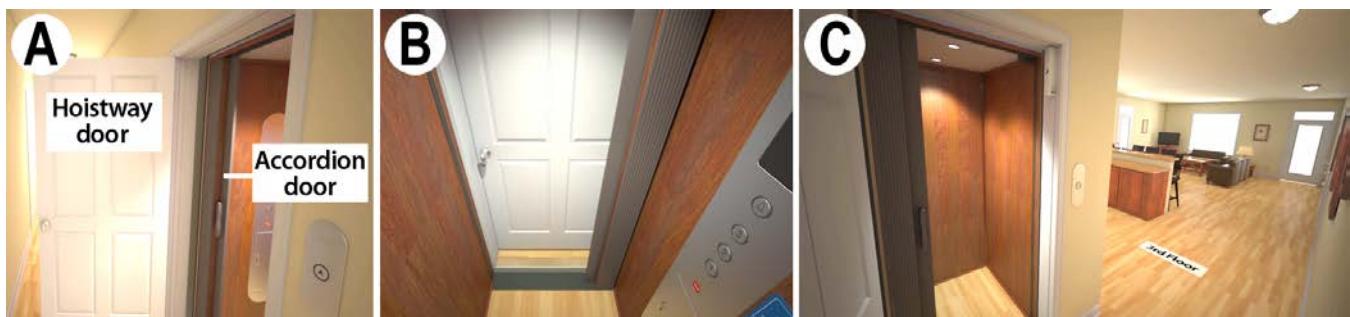
During Thanksgiving of 2013, a ten-year-old boy's family rented a vacation home in Murrells Inlet, South Carolina. The home did not have internal stairs, but did have an elevator as shown in Figure 1. The holiday turned tragic early in the vacation, when family members heard noises from the elevator and found the ten-year-old boy's body trapped inside and underneath the elevator positioned on the third floor on November 26, 2013. The boy suffered devastating traumatic brain and spinal cord injuries as a result of becoming entrapped by the elevator (U.S. CPSC, September 2014). As a result of this accident, the U.S. CPSC issued a recall notice citing that the elevator can operate while the gate door is open, posing a crushing hazard (U.S. CPSC, March 2015). The elevator seller has received three reports of incidents with the elevators, including the injured ten-year-old boy. The South Carolina Department of Labor, Licensing & Regulation found that the beach rental home contains two completely separate dwelling units and the elevator does not meet code (South Carolina Department of Labor, Licensing & Regulation, 2014).

Figure 1. Beach Rental Vacation Home Elevator.

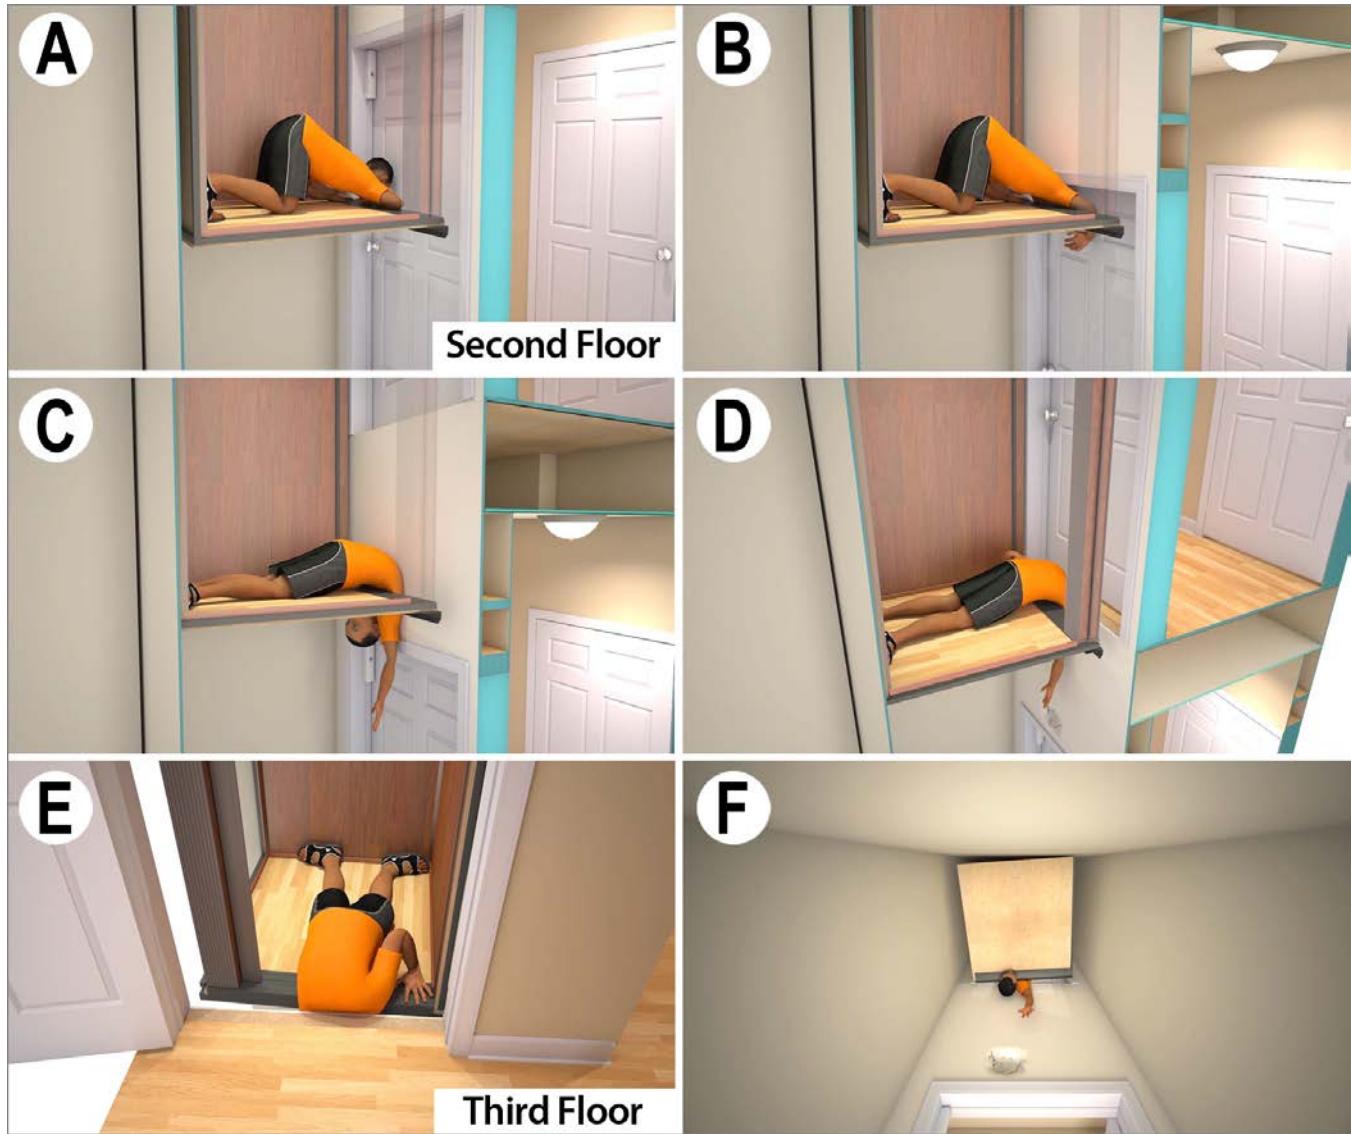
Figure 2 demonstrates an animated sequence of the accident reconstruction and elevator movement associated with the ten-year-old boy's entrapment accident. The boy was in the elevator on the 2<sup>nd</sup> floor and shortly after pressing the 3<sup>rd</sup> floor button, he was on his hands and knees with his hands at the edge of the elevator floor, and positioned face down with most of his head beyond the plane of the elevator with his head at or close to the floor (Figure 2A). This would allow the boy to look down below the edge of the elevator floor. The elevator rose to a point where the top rear portion of the boy's head contacted the upper horizontal portion of the 2<sup>nd</sup> floor door opening. The chin is overlapped with, and quickly contacts the floor of elevator. This creates a compressive crushing action between the top rear of the head and the chin that fractures the mandibular condyles, and creates the lacerations at the chin and mouth (Figure 2B). The space between the elevator floor and wall was not large enough to fit the boy's head so it acted as a restraint that pulled the neck and right shoulder area down as the floor continued to rise. The head stayed below the top of the door opening and pivots as the shoulders (more on the right than left) were crushed between the wall and the edge of the floor. As the elevator progressed above the 2<sup>nd</sup> floor doorway, the boy's body (likely the head) pressed against the inner wall of the elevator and fractured the drywall, creating a depression (Figure 2C). The head stayed below the bottom edge of the flange of the elevator floor trim, while the neck and shoulders (upper chest) were crushed between the elevator floor edge and the wall, creating the crushing fractures and injuries to the boy's scapula, ribs, and chest (Figure 2D). The head likely turned slightly to the left, exposing the left side of the head and face to the wall, where the laceration to the ear occurred. Throughout this process, the left hand stayed at the edge of the elevator floor, and the body became limp and the slumped to the floor.

Figure 2. Elevator Accident Animated Sequence (Car Moving Up from Second Floor to Third Floor).

In responding to the noises they heard from the elevator, witnesses described seeing the boy trapped in and underneath the elevator on the 3<sup>rd</sup> floor. The boy was found in the elevator limp and lying perpendicular to the doorway with his head, neck, and upper right chest below the level of the floor (Figure 2E). From below, the boy's head and right arm were seen below the level of the floor, and there was damage to the interior wall of the elevator shaft just above the 2<sup>nd</sup> floor door opening and directly in line with the path of the boy's head (Figure 2F). After a lengthy extraction, the boy was diagnosed with a traumatic brain injury consistent with an extended period of anoxia. The boy also received the following injuries: displaced fractures of the mandibular condyles bilaterally, multiple facial fractures, right clavicle fracture, multiple fractures to the right scapula, bilateral fractures to the first rib, large scalp hematoma on the posterior vertex, deep laceration of the chin, large lacerations of the left corner of the mouth and left ear, and bruising to the chest and shoulders.

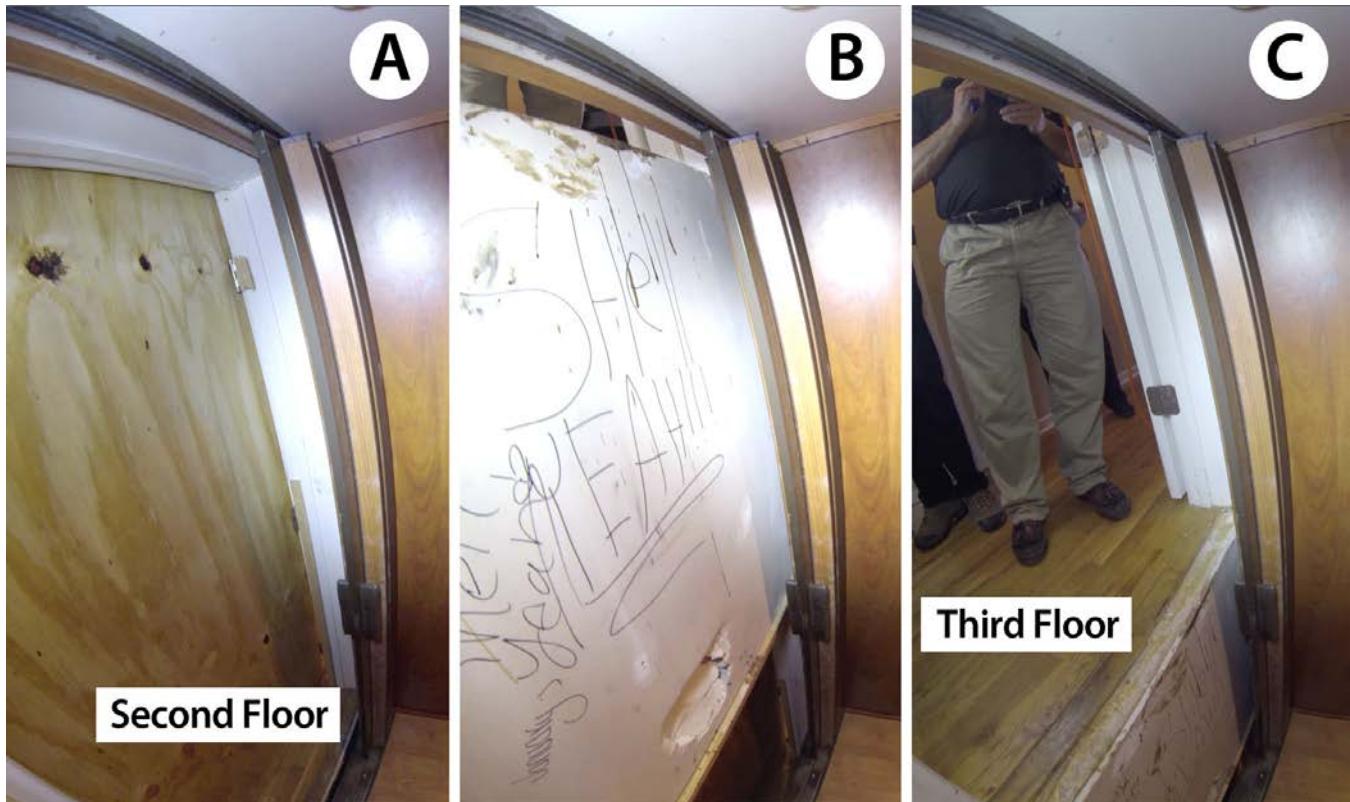
Regarding the control circuit, the primary issue in this case was the ability to operate the elevator with the gate door open. Analysis of the elevator control circuit schematics revealed a feature allowing the elevator to move in response to a call from another floor, even with the gate door open as depicted in Figure 3. This feature was only disabled for a period of 5 seconds each time the gate door opened (and elevator users presumably exited after arriving on a desired floor). After that 5 second delay, in case the users did not close the gate door after exiting the elevator, the controls would allow the elevator to travel in response to a call button pressed on another floor. Further investigation, however, including interviews of all witnesses present in the vacation home on the date of the accident, found that no call button had been pressed to cause motion of elevator at the time of the accident.

Witnesses interviewed during this investigation indicated they had observed the elevator moving between floors with the gate door open. They reported this behavior of the elevator had occurred during normal operation, not just in response to a call button on another floor. Further investigation therefore required a detailed inspection of the controls for the incident elevator. Inspection of those controls revealed a jumper wire that had been installed in a manner bypassing the safety features and allowing the elevator to be operated with the gate door open.

Figure 3. Elevator Video Sequence with Open Accordion Door (Car Moving Up from Second Floor to Third Floor).

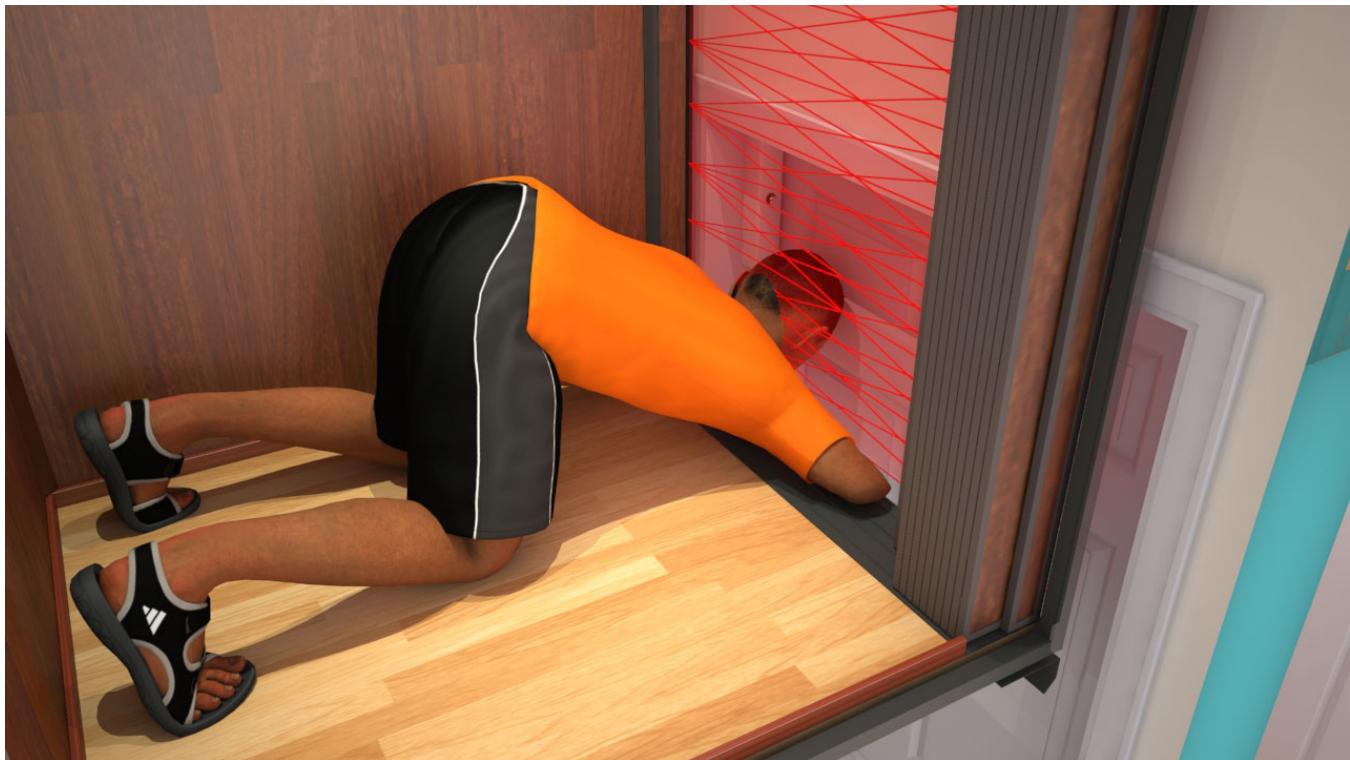
Additional research into alternate designs provided by the same elevator manufacturer found there were available models which included light curtains. This led to the question of whether or not the jumper wire found in the incident elevator controls would have disabled such a light curtain. It was determined that, based on analysis of circuit schematics for the various available models, the light curtain circuit, as configured in certain other models, would not have been disabled by the jumper wire. In summary, analysis of the control circuits led to the conclusion that it was feasible to include a light curtain in the incident elevator with only minor modifications to the existing circuits. Had a light curtain been installed in the subject vacation home elevator as illustrated in Figure 4, the ten-year-old boy's body would have been detected by the light curtain and the crushing injury would have been prevented.

Figure 4. Elevator Light Curtain Accident Prevention.

Results of this accident reconstruction investigation indicate that children, including teenagers, are capable of becoming entrapped between the residential elevator car and the hoistway door when the accordion door is open. The ten-year-old boy's injuries would have been prevented had the South Carolina beach rental home elevator been equipped with a light curtain safety device as offered by the elevator manufacturer on its other models. U.S. CPSC accident statistics indicate that residential elevator child entrapment injuries have occurred before and after the studied accident at issue. Petitioners to the U.S. CPSC assert that in many home elevators a child can become entrapped in the door path when the elevator is called to another floor, and the hoistway door automatically locks (U.S. CPSC, 2014). The child's body is carried along with the elevator car until the hoistway door meets the obstruction of the sill, where the child's body, usually the head, is crushed. Several technologies exist to eliminate this child entrapment hazard such as light curtains and door baffles (or space guards).
