Automatic Sliding Door Sensor Safety Analysis

Abstract: A female pedestrian wearing black clothing was injured when an automatic sliding door closed on her while she was standing at the right door threshold. An accident reconstruction was performed to document the injury mechanism. Testing of the automatic sliding door revealed presence sensor blind zones in the door threshold that are not identified when performing an American Association of Automatic Door Manufacturers (AAADM) safety check. Alternative presence sensor technologies are explored to prevent pedestrian-door contact events.

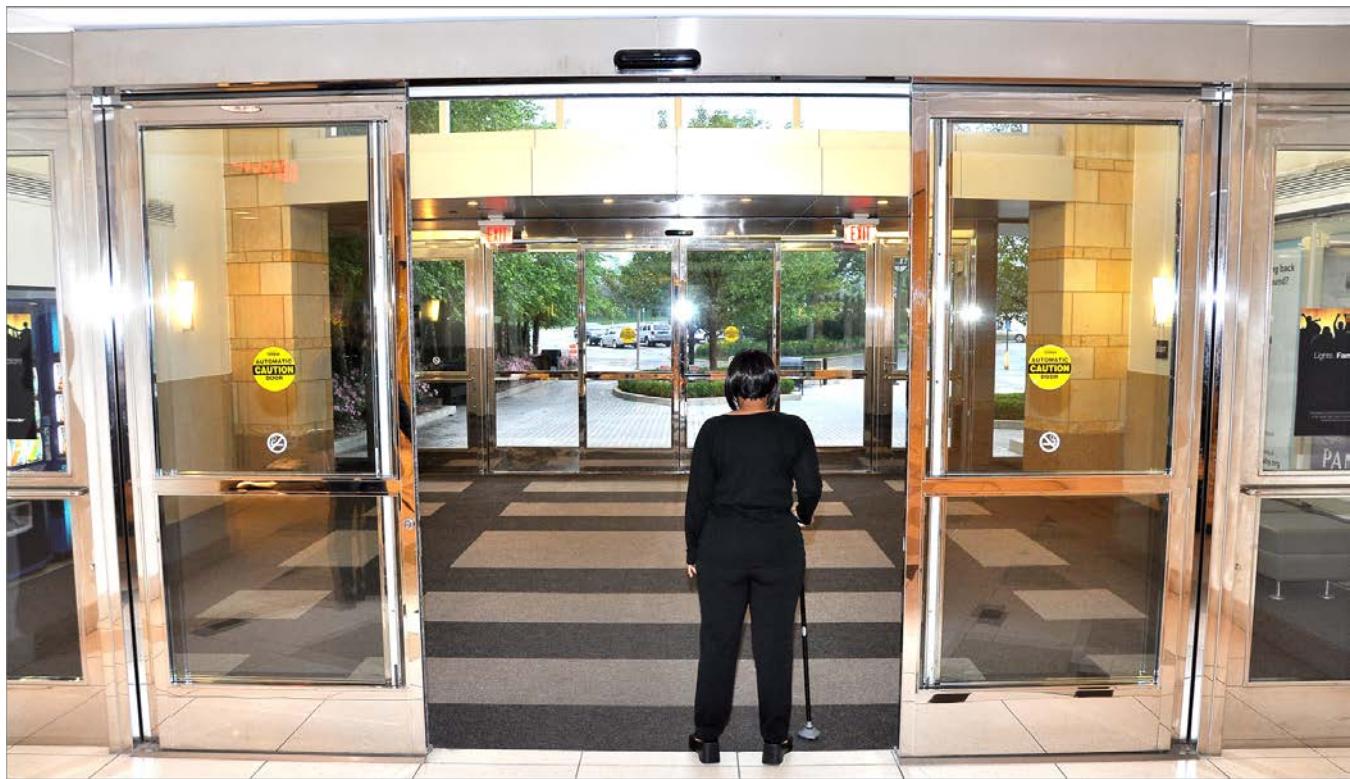
Figure 1. Automatic Sliding Door (Female Surrogate Holding Cane Standing in Door Threshold).

On the day following the accident, an American Association of Automatic Door Manufacturers (AAADM) certified inspector of power-operated automatic pedestrian doors tested the automatic sliding door at issue by standing in the door threshold with the door closing and contacting the inspector (AAADM, 2006). The inspector determined that the combination motion and presence sensors mounted on the header above the door on the inside and outside of the door were improperly functioning. Both combination motion and presence sensors exhibited a green blinking light, which indicates to the inspector that the sensor is reaching the end of its life cycle. The inspector found nine similar combination motion and presence sensors mounted on automatic sliding doors located in the facility following the accident that exhibited green blinking lights, which coincided with the doors closing on the inspector standing in the door threshold during testing. The manual associated with the combination motion and presence sensor did not indicate the meaning of the green blinking light. Other presence sensors display an orange flashing light when the sensor signals an internal fault (BEA, 2010).

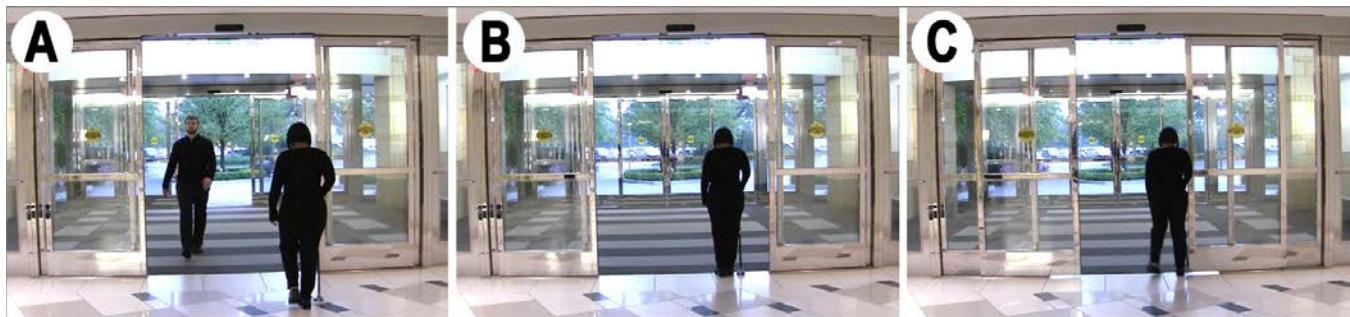
Figure 2. Accident Reconstruction (Female Surrogate at Right Threshold Contacted by Closing Door).

The subject accident was captured by a surveillance camera in the facility. Based upon a review of the surveillance video, an accident reconstruction was performed using a 62 inch tall female surrogate wearing black clothing as illustrated in Figure 2. Figure 2A depicts the female surrogate walking with a cane on the right towards the opening interior automatic sliding door from inside the building with another pedestrian on the left entering the building. In Figure 2B, the female surrogate is standing motionless at the right door threshold with her right hand holding the cane. Figure 2C demonstrates the female surrogate's right side being contacted by the closing automatic sliding door.

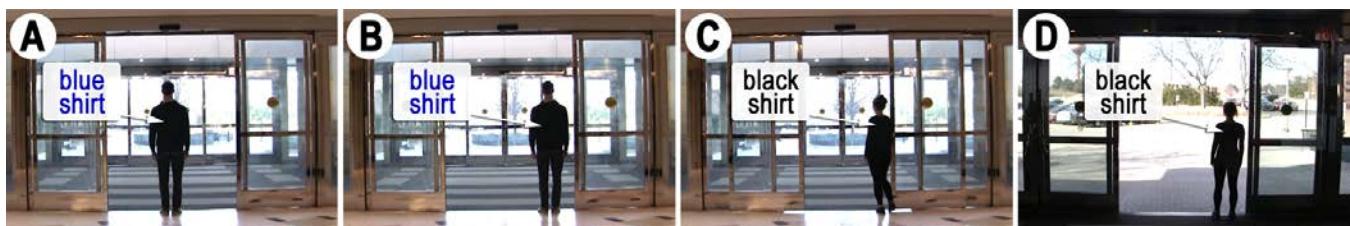
Figure 4. Automatic Sliding Door Safety Check (Surrogates Standing Motionless in Door Threshold).

Frames A, B, and C of Figure 4 show the results of performing a safety check on the automatic sliding door involved in the accident in accordance with the AAADM Safety Information label. Figure 4A illustrates the male surrogate wearing a blue shirt standing in the center accident door threshold where the door remains open. Figure 4B depicts the male surrogate wearing a blue shirt standing at the right accident door threshold where the door holds open. Figure 4C illustrates the female surrogate wearing a black shirt and black pants standing at the right accident door threshold where the door closes on the surrogate. Figure 4D shows the female surrogate wearing a black shirt and black pants standing at the right door threshold of another door in the facility equipped with a different model presence sensor than the sensor mounted on the accident door where the door remains open. This test program results demonstrate that performing the door safety check according to AAADM guidelines in the center door threshold with passing results can still result in a pedestrian being contacted by the same door.
