Best Safety Practices for Stability of PVC Pipe Bundles During Transportation

Keywords: PVC Pipe Bundles, Stability, Transportation

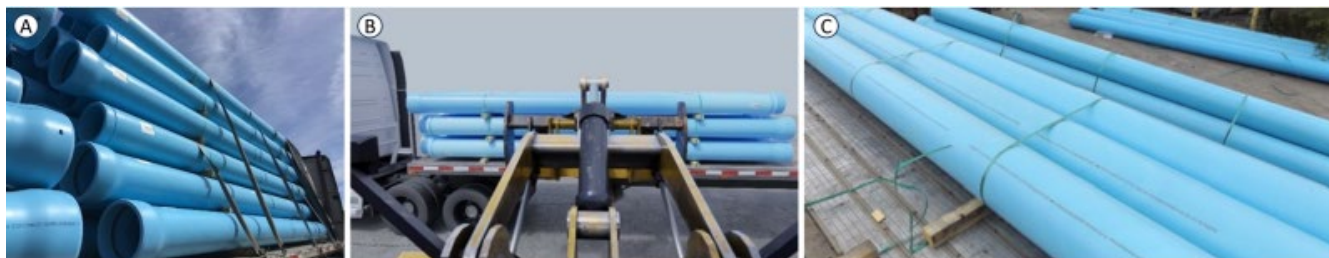
Figure 1. Pipe Bundles During Transport (A), Before Unloading (B), and After Incident (C)

During transport, one of the truck tie-down straps became partially torn due to the dynamic loading conditions. Photographic and video evidence indicates that the PVC pipe payload was unstable during the transportation process. Broken and crooked green PET straps and significantly shifted dunnage underneath the foundational pipe bundle on the trailer increased the instability of the pipe bundles. Two of the three bottom green PET dunnage straps on the ends of the PVC pipe bundle failed during transport, leaving only the middle green PET strap intact. Figure 1A shows the four pipe bundles on the passenger side of the trailer during transport.

During unloading, the truck tie-down straps were removed from the pipe bundles. A loader with a fork attachment was used to unload the pipe bundles from the trailer three rows at a time. Figure 1B displays the loader operator's view of the PVC pipe bundles at the time of the unloading process. During the unloading incident, the single green PET strap in the center of the bottom pipe bundle would have been insufficient to maintain integrity of the forward passenger side bottom foundational pipe bundle, causing the entire stack of pipe bundles to become unstable during unloading. Figure 1C illustrates the fallen pipe bundles after the incident.

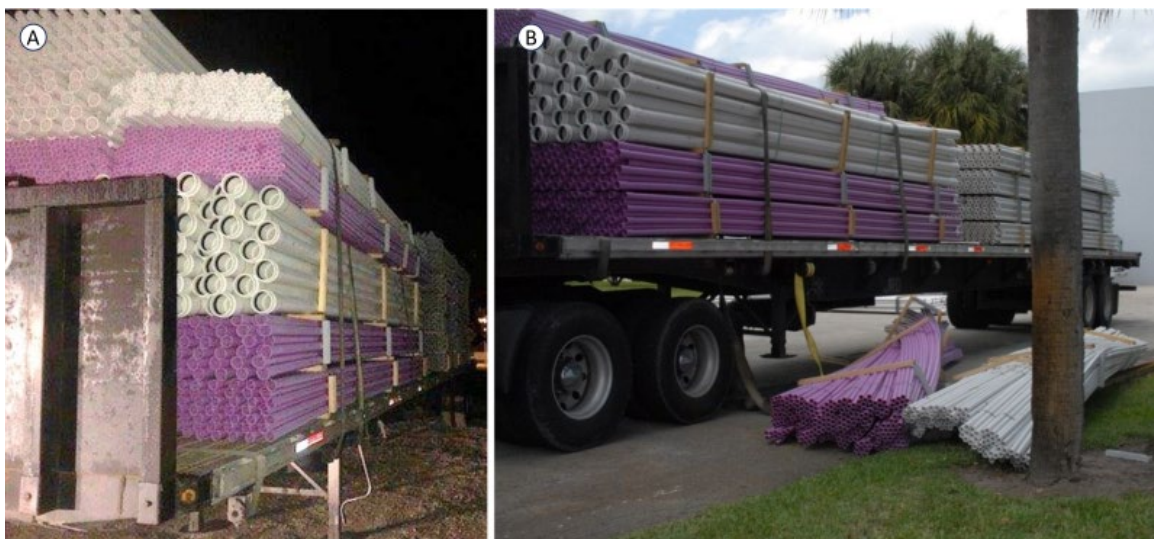
Figure 4. PVC Pipe Payload Prior to Leaving for Destination (Left) and After Incident (Right)

After arriving at the second customer's location, the truck driver loosened all the payload securement ratchet straps on the driver's side. Then the truck driver walked to the passenger's side to unhook the straps and throw the hook ends over to the driver's side or on top of the payload of pipe. At this point, the truck driver conversed with a forklift operator who then began to unload the pipe bundles from the passenger's side of the trailer. The truck driver returned to the driver's side of the trailer and began to roll the loosened straps back onto the ratchets attached to the trailer. At some point, the front stack of pipe pallets fell, striking and injuring the truck driver (Figure 4B).

Images taken before transport and delivery of the payload (Figure 4A) exhibits an improperly loaded and unstable payload of PVC pipe pallets. Heavier pallets of PVC pipe were stacked on top of lighter pallets, resulting in an elevated center-
