## Forensic Analysis of a Walker-Related Fall: Balancing Design, Safety, and Intrinsic Risk Factors

**Abstract:** Falls among older adults are a major source of injury, disability, and healthcare burden, with nearly one in three adults over the age of 65 experiencing at least one fall annually. While mobility aids such as walkers and rollators are commonly prescribed to mitigate this risk, improper use, poor fit, and device-related issues can inadvertently contribute to fall incidents. This paper presents a detailed forensic analysis of a fall involving a 75-year-old man who sustained a right hip fracture while using a front-wheeled walker with a fold-down seat in his home. The investigation sought to determine whether the deformation of the walker observed after the incident was a cause or consequence of the fall. A comprehensive approach was employed, integrating physical inspection and three-dimensional scanning of the damaged walker and an undamaged exemplar, standardized load testing per ISO 11199-1:2021, and reconstruction testing simulating fall dynamics. Additional review included the user's medical and fall history, product labeling, and the FDA's MAUDE database for adver

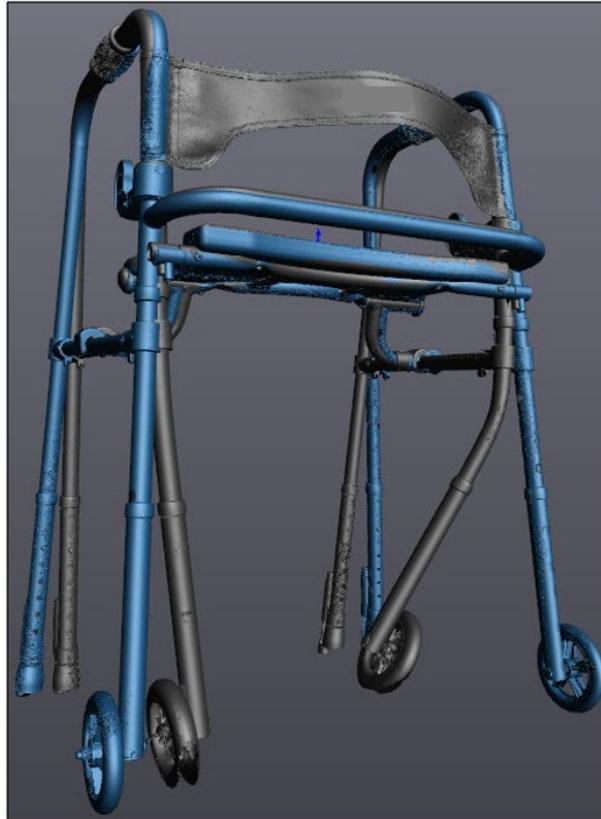
The physical inspection and scan data revealed that the subject walker exhibited multiple inward and rearward deformations to its front and rear legs, most notably at the left front leg. When compared to an undamaged exemplar through three-dimensional overlay, these deformations were found to be localized and directional – suggesting that significant external forces were applied laterally and asymmetrically (Figure 1). The pattern of damage was inconsistent with forces that would occur during upright use or even foreseeable misuse while the walker remained upright. Instead, the configuration of the damaged frame pointed to loading from outside the walker's envelope after it had tipped.

Figure 1. Overlay of the subject walker geometry (dark grey) with an undamaged exemplar walker (blue)

The subject walker, which had been retained after the incident, exhibited visible signs of damage including inward deformation of the left and right front legs and distortion of the lower frame. The unit was documented with high-resolution photography and then scanned using a three-dimensional laser scanner to capture its geometry with sub-millimeter accuracy. An undamaged exemplar of the same model was also scanned using the same protocol. These digital models were overlaid to visualize and quantify deviations in leg positioning, cross-brace orientation, and handle symmetry.

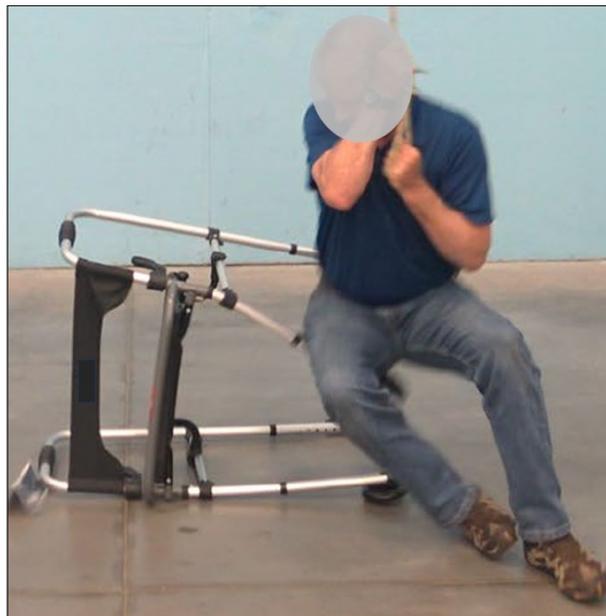
A controlled loading fall was conducted to determine whether the damage pattern could be reproduced under plausible fall dynamics (Figure 2). When subjected to lateral impact while tipped, the exemplar walker developed inward bending patterns that closely matched those observed in the subject unit (Figure 3). This finding further supported the hypothesis that the walker's frame was deformed during, not prior to, the incident.

Figure 2. Controlled loading fall onto exemplar walker laying on its right side

To replicate the observed damage pattern and evaluate whether it could result from a fall involving lateral body contact, a reconstruction test was conducted using an undamaged exemplar walker. The walker was positioned on its side such that the legs on one side were supported by the ground while the opposite legs were suspended, mimicking a tipped-over orientation. A controlled, partial-weight fall was performed onto the elevated front leg using human body mass to simulate lateral impact. The resulting deformation of the walker – particularly the inward bending of both front legs – was then compared to that observed on the subject walker. This test provided insight into whether the specific pattern and degree of deformation could occur as a result of external loading during a fall.

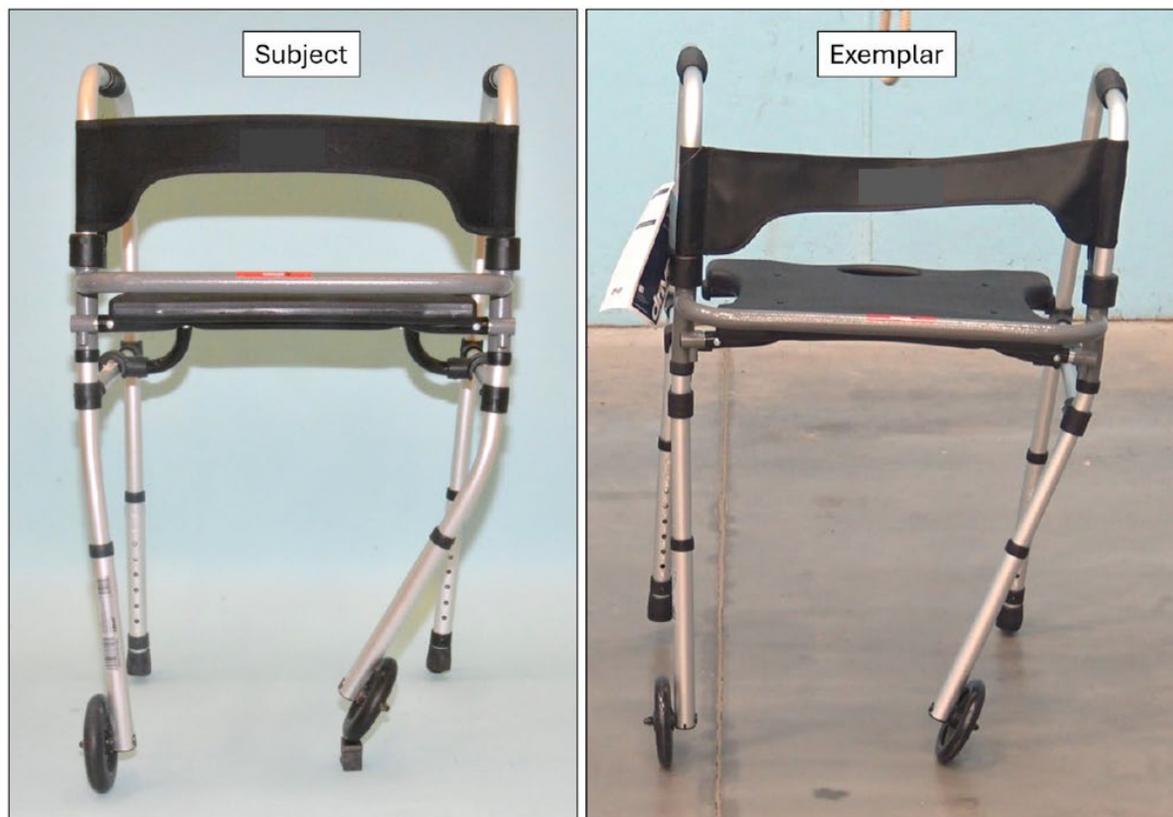
Figure 3. Comparison of damage between the subject walker and the exemplar struck in the controlled loading fall

The investigation concluded that the walker involved in the incident was structurally sound prior to the fall and did not exhibit signs of latent defect or mechanical failure. The deformation observed in the frame – particularly the inward and rearward bending of multiple legs – was determined to have resulted from external loading during the fall event, not from a collapse or malfunction under normal use. This conclusion was supported by detailed scan comparisons, standardized load testing in accordance with ISO 11199-1:2021, and physical reconstruction of the damage using an undamaged exemplar walker. Further, a review of adverse event data did not reveal a pattern of similar structural issues associated with this walker model. Together, these findings provided a consistent body of evidence indicating that the walker did not cause the fall but was instead damaged as a consequence of it.
